Combe Mill

Restoration of the Line Shafting to working order

Written by Richard Brown

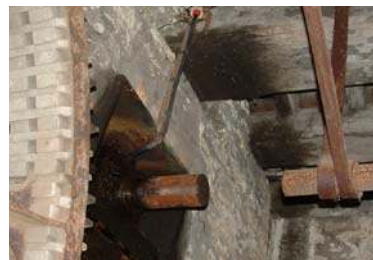
End of line shaft and support for disengaged gear wheel

shaft. This pipe could slide in line with the shaft and be locked in position with a pin. So the pipe was moved to touch the line shaft and locked in position. The key in the gear came out easily and was

placed alongside the adjacent bearing. The gear then slid easily off the line shaft onto the pipe. The line shaft was now free to turn without trying to turn the water wheel. This gear wheel, weighing about ¼ ton, looked a little precarious, twelve feet above the floor, so we looked for ways to lower it. We had a ½ ton chain hoist so a young son was sent upstairs to locate a suitable board to lift. A voice came down from above "No problem Dad, there's a trap door here." So the hoist was rigged and the gear safely lowered to the floor where it still rests.

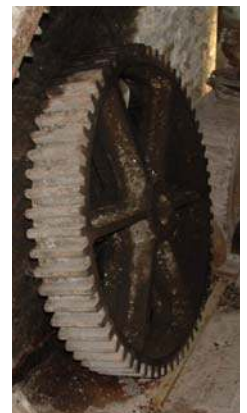
Gear wheel which drives line shaft. Now on floor

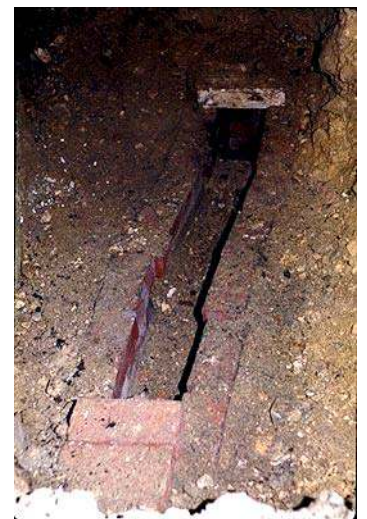
Brick lined drain under plinth carrying new bearing

The next stage was to build a plinth to support the pedestal bearing. We realised that there was a lot of power in the fly wheel and if the belt got caught up, it could easily rip out anything flimsy. So it had to be robust. We noticed that most bearings were supported on wood. We had a piece of oak 11" X 7" which came from the lintel above the window alongside the boiler when we put the door in and decided to use that. We dug a hole where the pedestal had to be 3 ft X 3 ft and 3 ft deep. During digging an old brick lined drain was found but we were unable to locate where it started or finished. We made up two 1" dia holding down bolts 4 ft long bent a right angle at one end. A frame was made to hold the bolts in the right place and we hand mixed the yard of concrete to fill the hole. A brick plinth was built to the necessary height and the oak beam placed over the bolts. Finally, the pedestal bearing was placed over two bolts through the oak ready for the stub shaft.

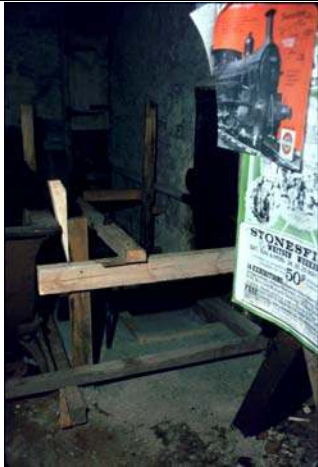
Frame locating holding down bolts

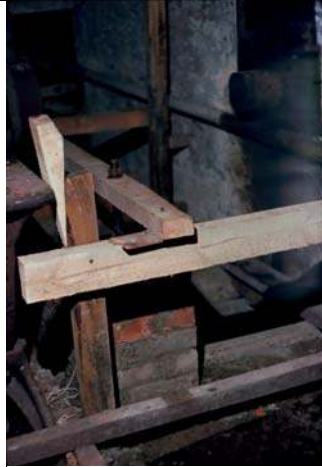
Plinth partly built

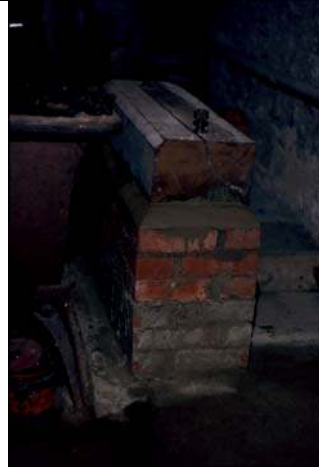
Completed plinth with the oak beam above

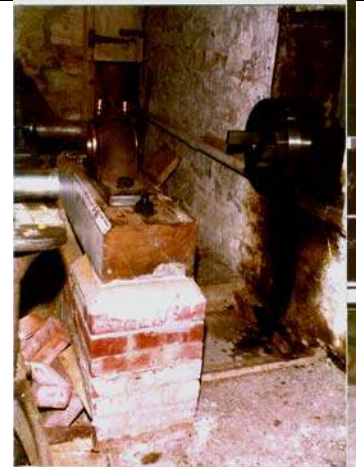
Plinth with bearing located and wedges in couplina beina fitted

The new coupling was placed on the end of the crankshaft and fixed loosely with the four wedges. Two dial test indicators were set up to enable the coupling to be aligned. One measured the error on the face and the other the error on the register. No photographs were taken during this period. Over the next six months or so every Thursday evening was spent filing the wedges to correct the out of true and then barring the engine over to check what error remained. It was a long tedious job. Eventually the error was reduced to + 6 thou, - 6 thou, a total error of 0.012". As this could not be reduced, it was considered that this error was in the engine its self so it was decided to fix the coupling at that. Using a 14 lb sledge hammer and straddling the crankshaft, the four wedges were driven home, never to be removed. The out of true remained the same so the new 3" shaft and pulley could be installed.

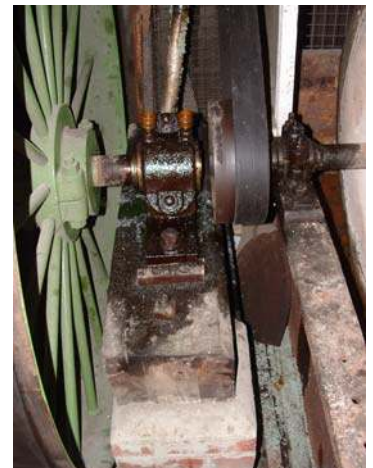
New bearing and pulley installed

The 3" shaft was set into the other half of the coupling and the key driven home. The shaft was then passed through the 60" dia pulley, the clamping bolts tightened up and the rim screws fitted. The assembly was then rolled into position and lifted so that the shaft sat in the new bearing and the two halves of the coupling could be mated and bolted up with 6 X 1" dia bolts.

The previously selected pulley of 24" dia to give the line shaft a speed of about 100 rpm was installed on the shaft. Oil cups were made and fitted to the bearing and guarding made to enclose the belts. A suitable belt was obtained and fitted to the pulleys and all was ready for the next steaming weekend to test it.

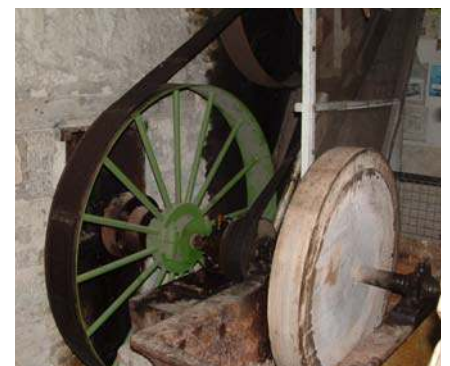
Plinth, bearing, coupling, whet stone and belts fitted and ready to run

A suitable leather belt was fitted to drive the whet stone direct from the shaft. The bearings were checked and cleaned and filled with steam oil. The end of the shaft was rather long and had interfered with the end of the new shaft on the engine so a short section had to be cut off. It proved to be wrought iron.

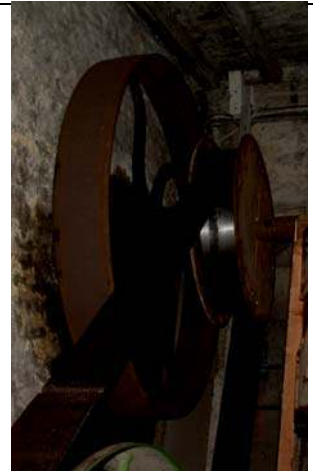
The first run was a little disappointing as the belt came off and got tangled up with the pulley and was torn apart. A new cotton belt was fitted and wooden flanges fitted to the line shaft pulley to prevent the belt coming off. It was run again on the next open day and has run successfully ever since - nearly 30 years.

The new 24" dia pulley with flanges alongside the original pulley drive from the engine

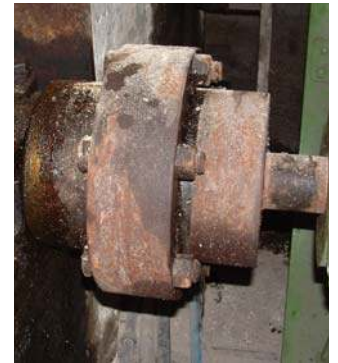
The coupling after about 30 years use

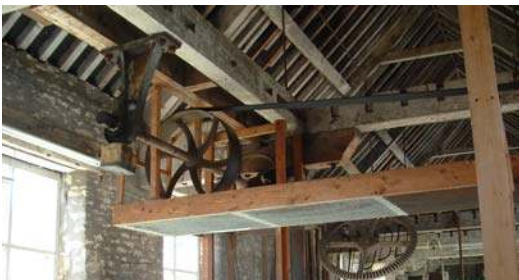
Lay shaft taking drive from line shaft to lathe and bandsaw

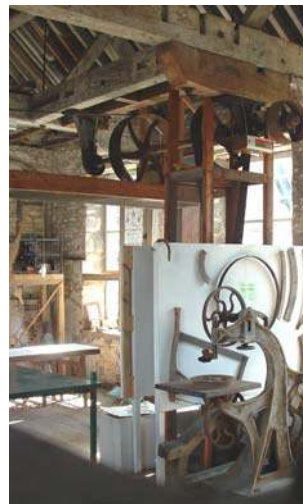
Bandsaw below lay shaft

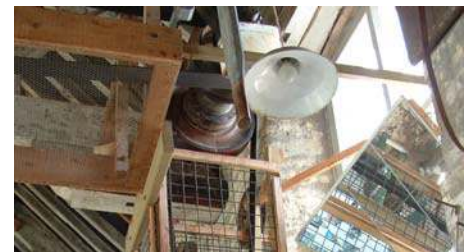
Striking gear for lathe to enable it to be started and stopped

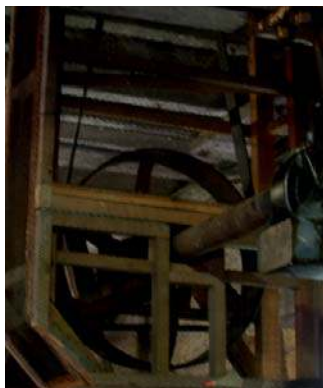
Pulley on line shaft taking drive upstairs

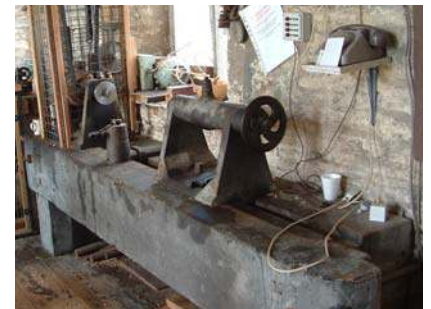
The lathe

Originally, the lathe upstairs was driven from the line shaft so this was the next task to refurbish. Suitable belts were fitted to take the drive upstairs to the lay shaft and then to the striking gear above the lathe. The bearings on the lathe were overhauled and a belt fitted from the striking gear to the lathe. It worked well and demonstrations of wood turning could now be given to our visitors.
