Combe Mill

Maintenance of Beam Engine Cold Well – Winter 2010/2011

Maintenance of Beam Engine – Winter 2010/2011

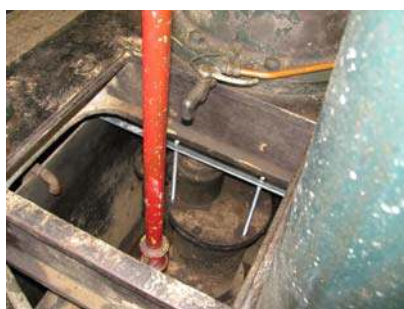
These included tightening the bolts as far as possible, fitting new wood wedges underneath the condenser and fitting studding to (i) hang the condenser from an angle beam supported from the rim of the cold well and (ii) later, to hold this beam down, so the condenser was fully restrained vertically.

Studding supports

Wooden wedges under manifold

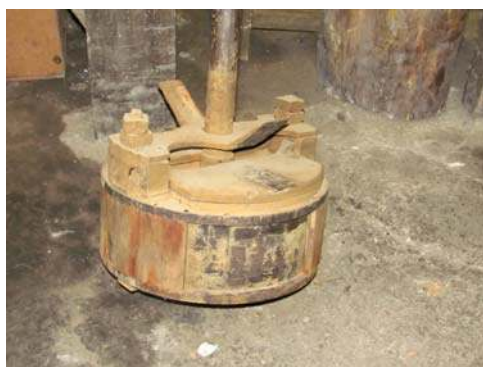
Missing wood strips on air pump piston

Flange has to be removed first as it is larger in diameter than the gap in the beam engine base. Removed the piston and short rod. The piston seals are axial wood strips and 25% were missing and the rest had been worn down to the steel rings above and below the strips.

All strips must be replaced and then machined down to give a good fit to the bore.

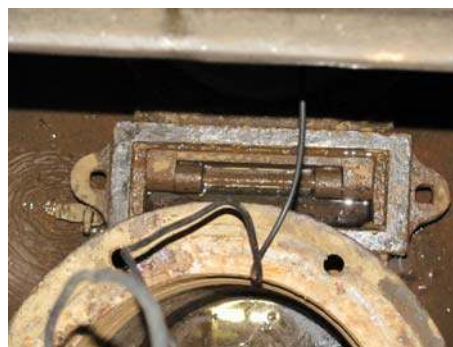
Removed the cover plate over the bottom flap valve. Seemed in good order. Tried to lift out the valve but not possible. Left as is. New gasket needed 3 x 180 x 430 mm. See C on diagram.

Cold well bottom flap valve seen from above

Gasket material and gland packing received from I B S. Cleaned up faces of bottom flap valve cover plate, refitted it. Needed double gasket (2 x 3mm) to seal properly – see C.

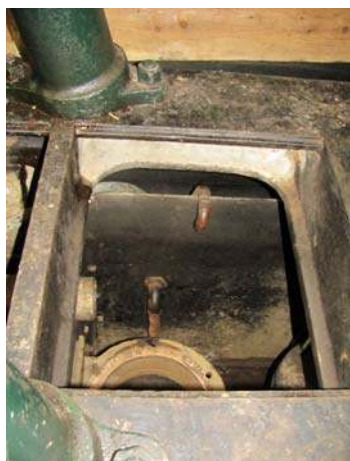
Small engines' condensate system pipes

Identified the pipes on flywheel side of cold well tank: Steel pipe through wall of cold well supplies cooling water to the small engine condenser via the Weir pump or, alternatively, via the small green pump driven by the Bradford. 2" copper pipe over the side returns cooling water from that condenser. Plastic pipe delivers condensate coming from that condenser via the grey pump driven by the Bradford.

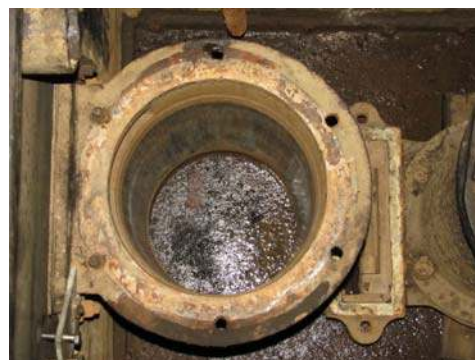
Inside of air pump

We measured the bore of the cold well pump:
North is the valve box, east is the door.

(Note: Roughness of the bore means that diameters cannot be accurate to better than 0.005 ins or 0.1 mm) Mean diameter = 332.7 mm

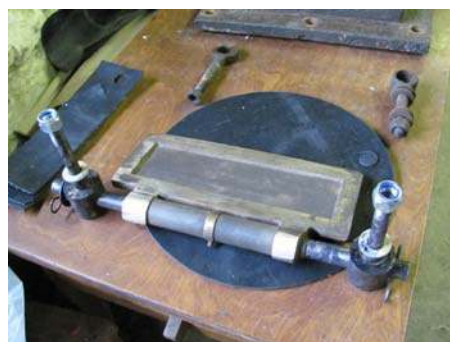
Removed the top flap valve; gasket in very poor state, flap valve not flat so needs dressing and the pivots for the hinge are broken and need repositioning to get an acceptable seal on the flap valve; preferably the hinge position needs to be well defined so as to get a good face seal from the flap valve to the opposing face. Assembly removed to JR's for fixing. See D on diagram.

New flap valve components

Collected machined items for the top flap valve from Mach-Tech. Reassembled the valve and progressively machined the pivots back to get a good closing of the valve plate. Actual gap when finished was around 0.005 ins or 0.1 mm. To allow the valve plate to open to 90 degrees, the material on the back of the flap valve hinge had to be relieved; if this works, it will allow the removal of the temporary wooden block, which had been added to limit the opening of the flap valve and stop it jamming open.

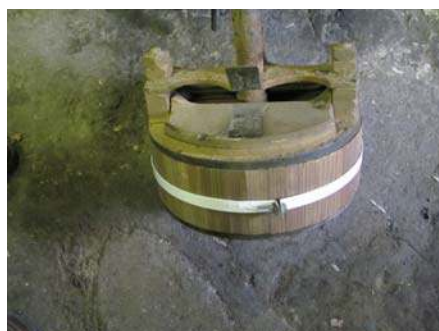
New teak strips with temporary retainer band

The new teak packing on the piston was machined by Mach-Tech to 332 mm dia and at the same time the flanges at each end of the wood packing were skimmed to 330 mm dia, making the wood proud of the metal by 1mm on radius.

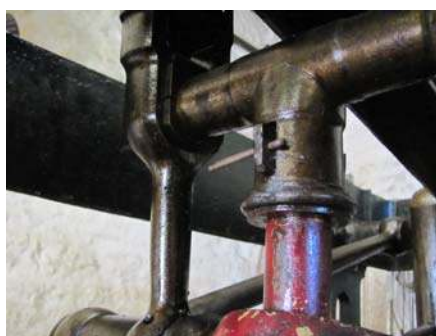
Added split pin

Split pins were added to retain the wedges as, if one wedge fell out and the operating pull rod did not re-enter the socket, there would be a major catastrophe: either the pull rod would buckle (unlikely) or the piston would punch a hole in the bottom of the air pump. This is not to be recommended!

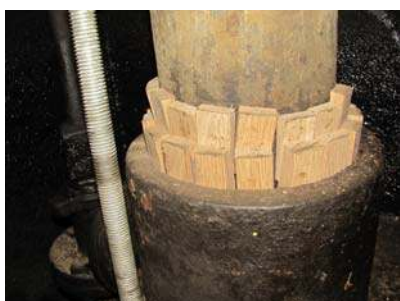
New oak wedges for condenser seal

Re packed the seal from steam exhaust into the condenser – see A - using IBHS product 50-474-2M Klinger 49 packing, 3/4 inch square.

Wedging it in place with oak wedges about 80 mm long x 25mm x 18 mm at thick end with short taper at top end. These wedges are used to compact the packing and are only held down by the second short wedge which is driven in from the top and follows up the main wedge as the packing is compacted.

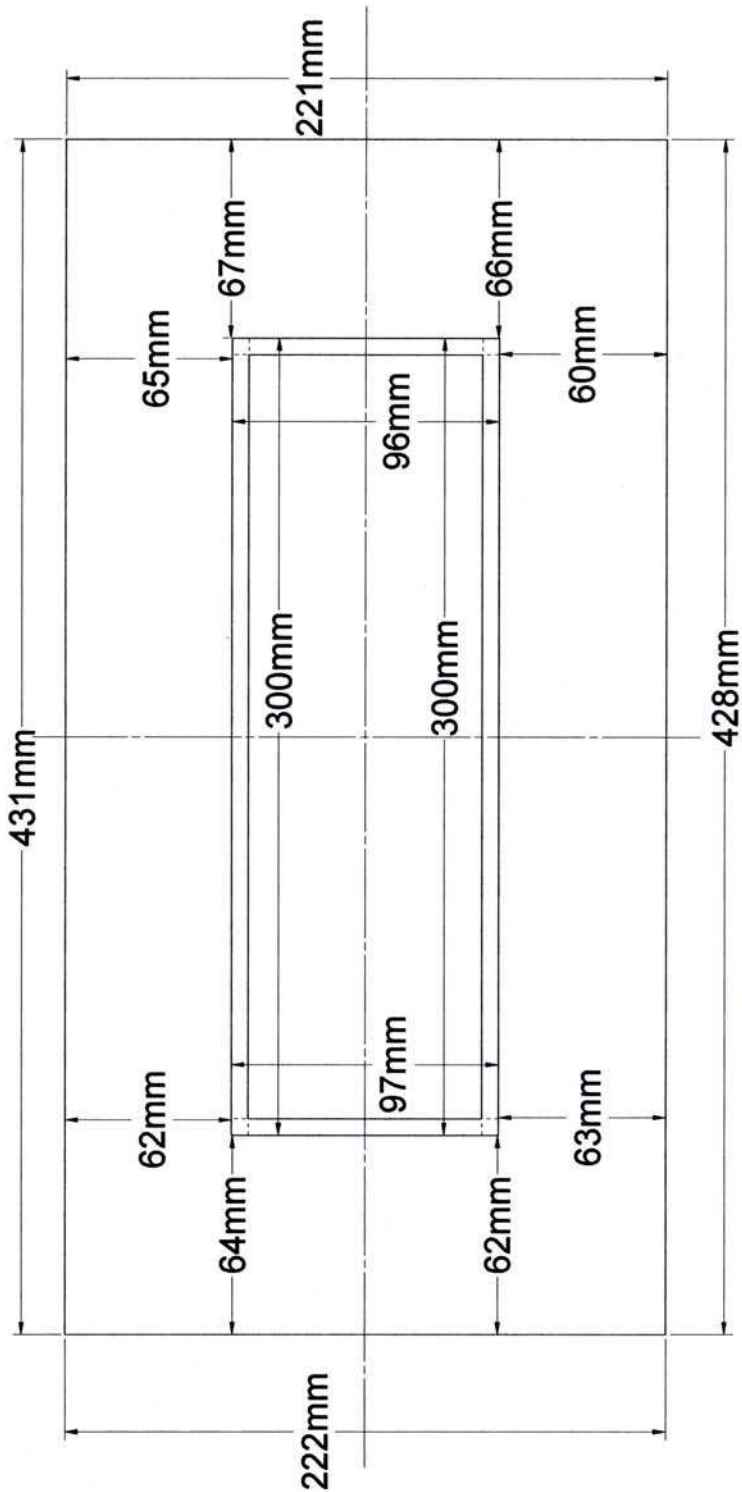
Cold Well/Hot Well gasket

**Combe Mill
Cold Well / Hot Well Gasket
Original measurements by John Ross
PJH Nov 2010
Gasket Thickness 3.4mm
Mark fixing holes from flange and cut as required**

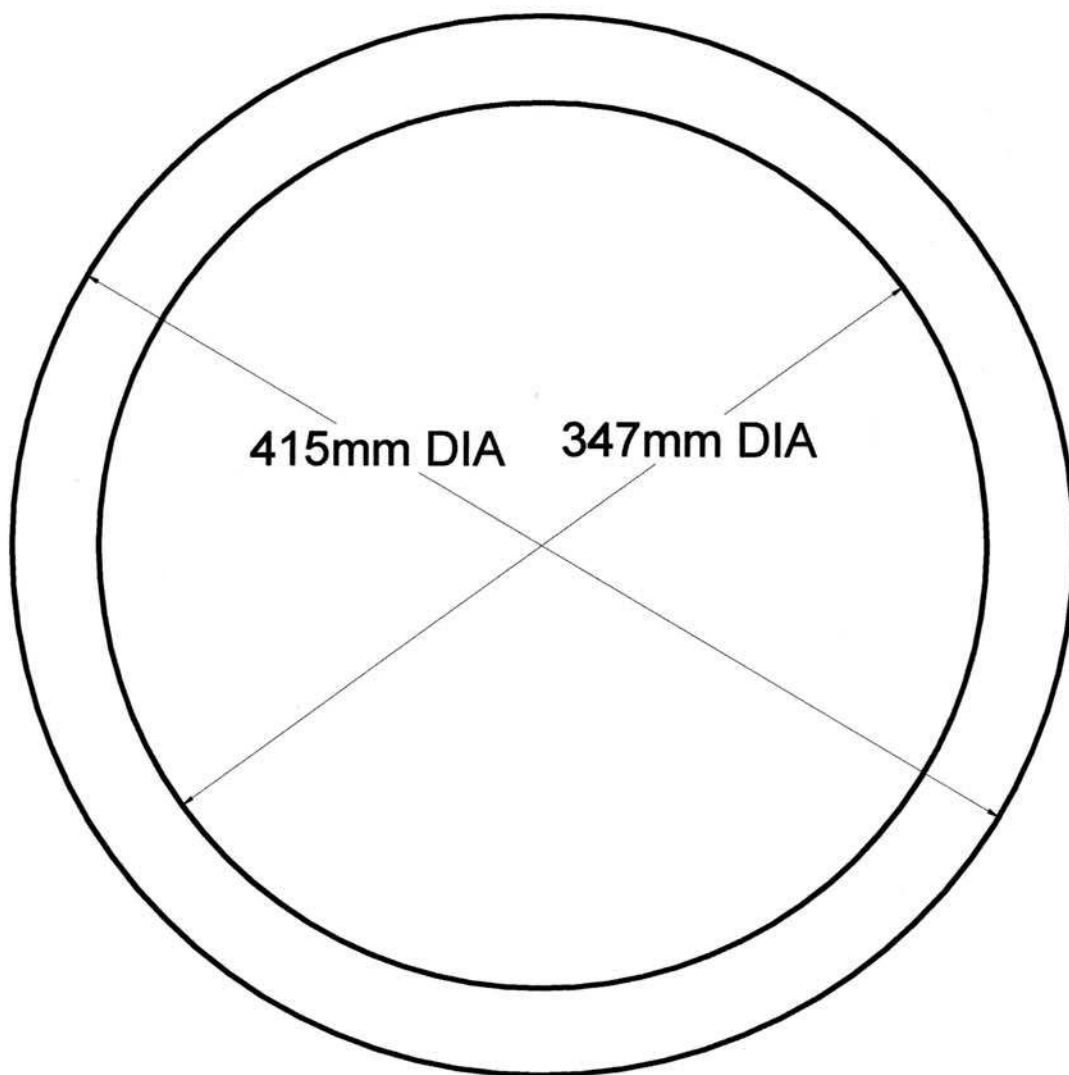
Air pump top flange gasket

**Combe Mill
Air Pump Top Flange Gasket
PJH Nov 2010
Gasket Thickness 3.4mm
Cylinder cover retaining bolts are not
concentric with the bore therefore
cut away gasket as required**
