Combe Mill

Work on the Beam Engine May 2006

Report on Work on the Beam Engine at Combe Mill on 19 & 21 May 2006

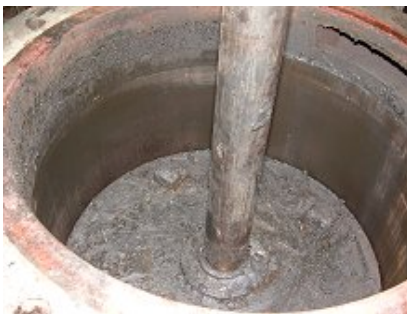
Top of piston showing contamination (5)

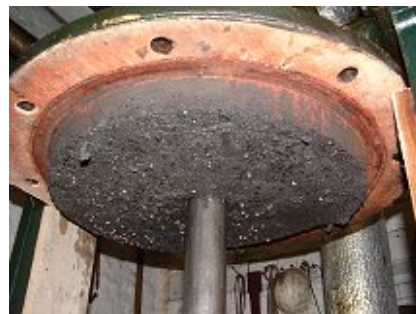
Underside of piston showing contamination (5)

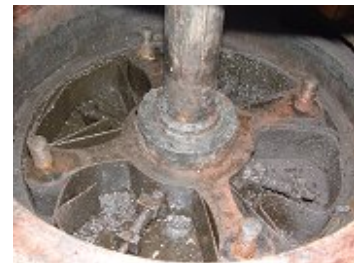
Top plate of piston removed showing jumble of metal and contamination (7,8)

9. It was found that the springs shown in the diagram of the piston were useless and some loose pieces were removed. One was left in each of the 4 sections.

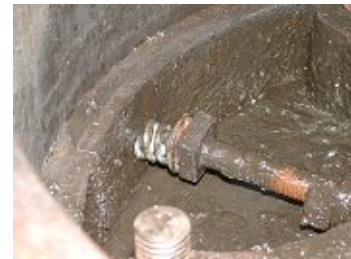
Inside of piston showing one spring on end of adjusting screw (10)

10. 2 car valve springs were cut in half and one fitted, with washers, on to each of the 4 adjusting screws. The screws were then screwed out to give some radial pressure to the flat spring left in position so that it could spread the new spring pressure radially to the piston rings.

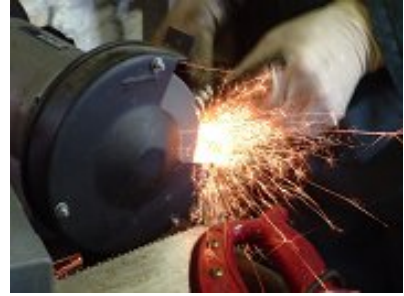
Cutting the springs (10)

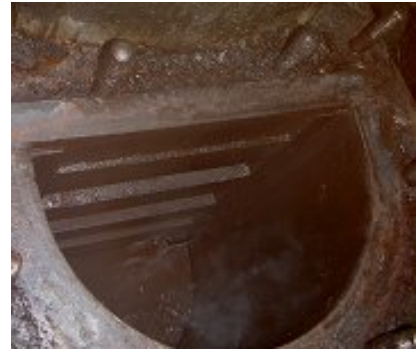
Inside of valve chest showing port face

No apparent damage was found and the whole thing replaced. The engine could be run if the Roller boiler pressure was at 150 psi and the water level in it at the lowest safe level (therefore maximum volume of HP steam)

At lower pressure, the engine stopped. It seems probable that due to lack of pressure in the valve chest, the valve is not pushed into contact with the port face.

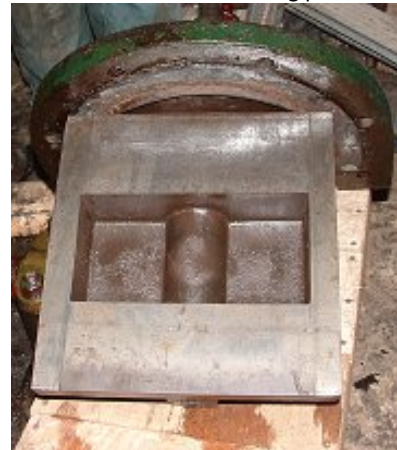
Valve showing face
