## ***Combe Mill***

**Repair of Beam Engine main steam stop valve**

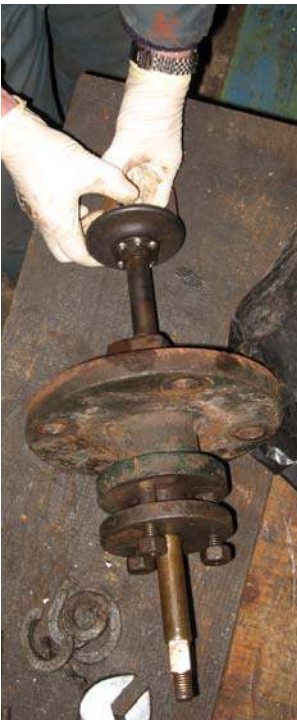
As soon as we could, the valve was pulled apart and it was found that screw threads in the cone for the retainer holding the end of the valve spindle had stripped allowing the valve cone to be pushed by steam pressure into the closed position. Hence the reason for the engine to stop.

Valve top, spindle and cone after repair

Six stainless steel screws were obtained. The cone and retainer were assembled and drilled to the tapping size and the retainer removed. The cone was tapped to suit the new screws and the retainer drilled clearance size.

The repaired parts were returned to Combe and the valve assembled and fitted to the main body where it has functioned satisfactorily ever since.

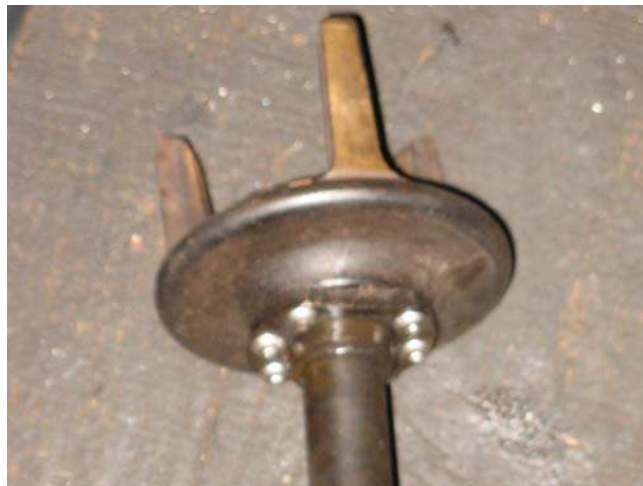
Close-up of cone showing the repair with stainless steel screws
