Combe Mill

Work on the Beam Engine May 2006

Report on Work on the Beam Engine at Combe Mill on 19 & 21 May 2006

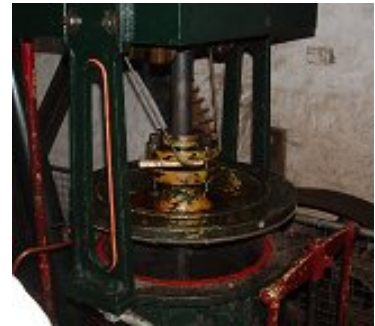
Splitting the cylinder cover (1)

1. Remove cylinder cover bolts, ensuring that bolts and nuts were kept paired. Note that the two bolts nearest the valve chest had cut-away heads
2. Remove one gland retaining bolt, slip a wire rope sling into the gap and replace the bolt.

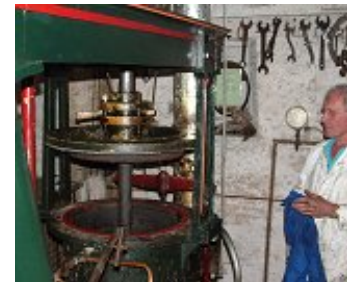
Lifting the cylinder cover (4)

3. Lower the piston to BDC and pass the wire rope over the beam and connect the ends with a shackle. Insert 2 small pieces of wood to protect the wire rope from the corners of the gland.

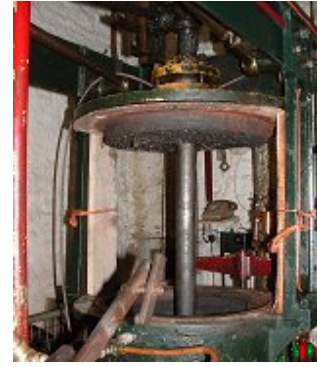
Cylinder cover held on two boards (4)

4. Bar the engine over to raise the cylinder cover until it almost touches the entablature. Place 2 pieces of board, one either side, as supports (tied to the uprights) and lower the cover to rest on them.
5. Lower the beam to release the wire rope and then raise to get the piston to TDC. (A thick layer of grease and gland packing was found on top of the piston which was removed)
6. Remove the 4 fixing nuts, again taking care to note which nut paired with each stud.

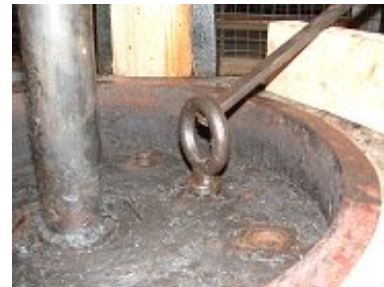
Removing top plate of piston (7,8)

7. Remove the 2 square headed bolts and replace them with 2 eyebolts (we only had one and improvised the other)
